Root Cause Failure Analysis of Castings: A Case Study of a Brake Rotor

Samuel A. Awe

Abstract

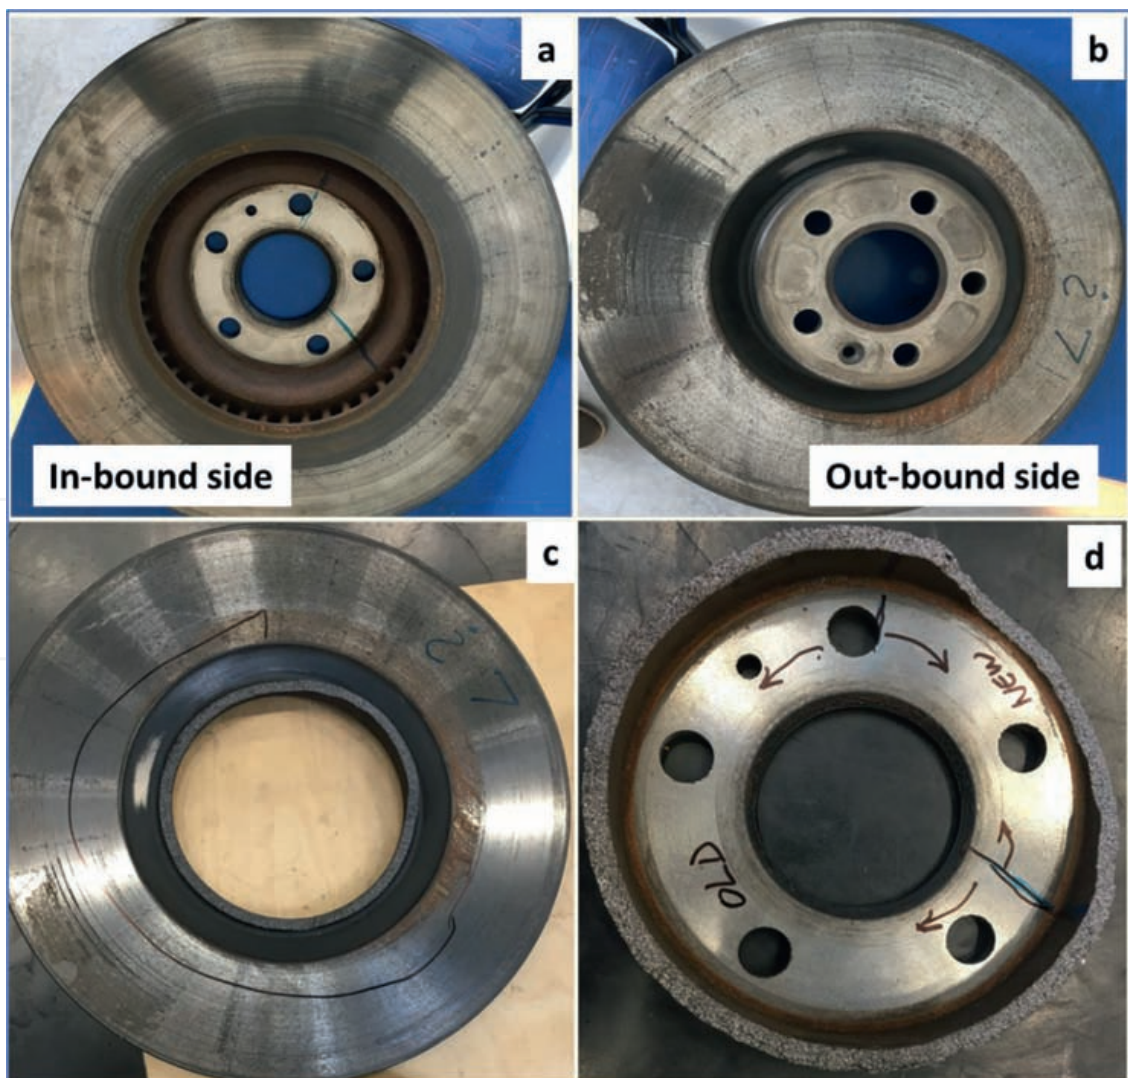
Figure 2.
The as-received brake rotor (a) in-board (b) out-board sides of the disc, and (c) and (d) represent the split rotor.

The failed “as-received” brake rotor was carefully examined before cutting samples out of it to observe any signs of aggressive use or inappropriate installation of the rotor with other brake system components, such as pads and calipers. As shown in **Figure 4**, a circumferential crack was noted at the swan neck region of the rotor, indicated by the arrows. The damage covered over 75% of the disc neck perimeter. It is also observed that the in-board area and the rotor's vents have been rusted, while the out-board region is still coated with graphite black paint that protects it against corrosion. A thorough examination of the brake surfaces (in-board and out-board) does not suggest any symptoms of abusive use of the rotor (**Figure 2a** and **b**). The friction planes do not show a blue discolouration marking. Blue discolouration of the friction surface emanates from excessive heat generated from braking due to the misalignment of brake calipers or inadequate heat dissipation by typical brake components [27]. This discolouration could occur due to extreme pressure mounted on the brake pads even when the brake system is not used. However, the brake surface blue marks

can suggest faulty calipers and brake pads, disc cracks, and non-uniform brake pad wear. This analysis does not indicate any of the abovementioned issues as the cause of the failure, implying that the rotor was installed correctly and operated normally.

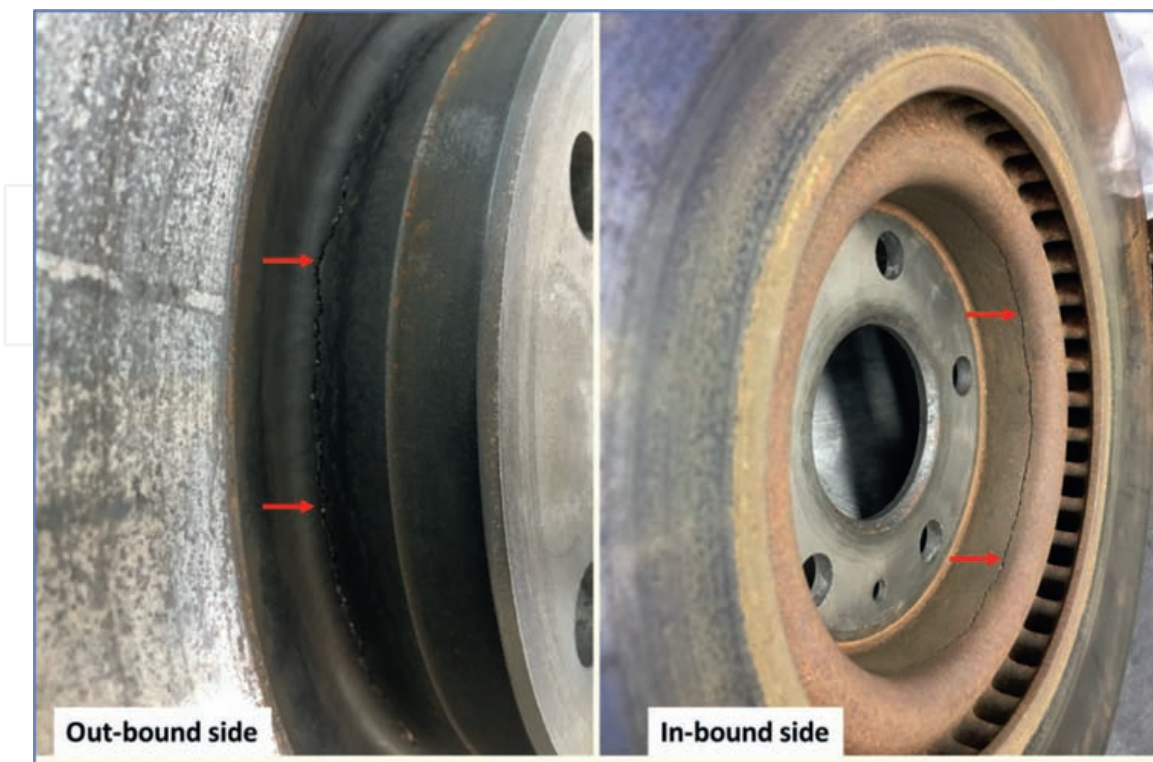
Figure 4.
A circumferential crack around the swan neck of the rotor.

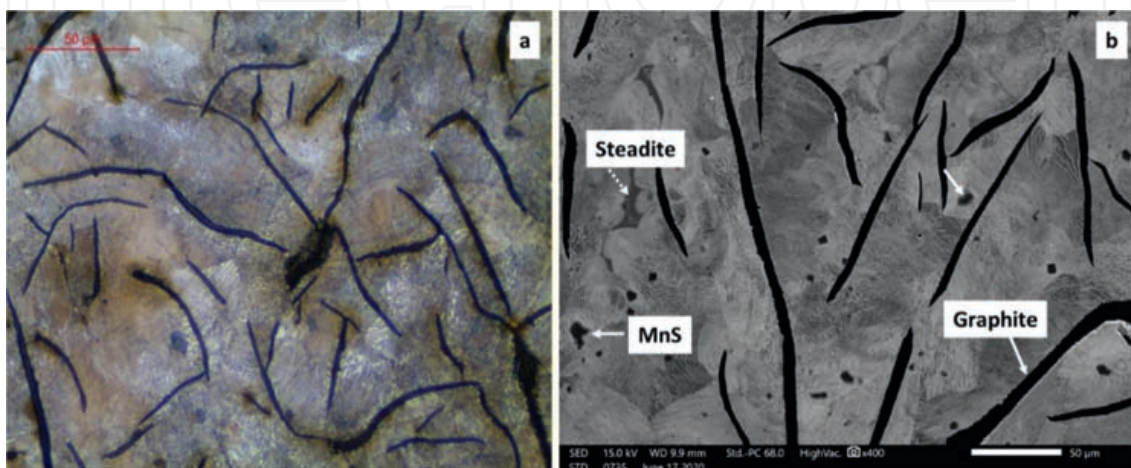
Figure 6.
Light optical (a) and SEM (b) micrographs of the rotor.

with a few manganese sulphide (MnS) particles and traces of steadite. It can be concluded from this study that there were no inconsistencies in the microstructure constituent of the failed disc, and therefore conforms with the microstructural specification for the disc material.

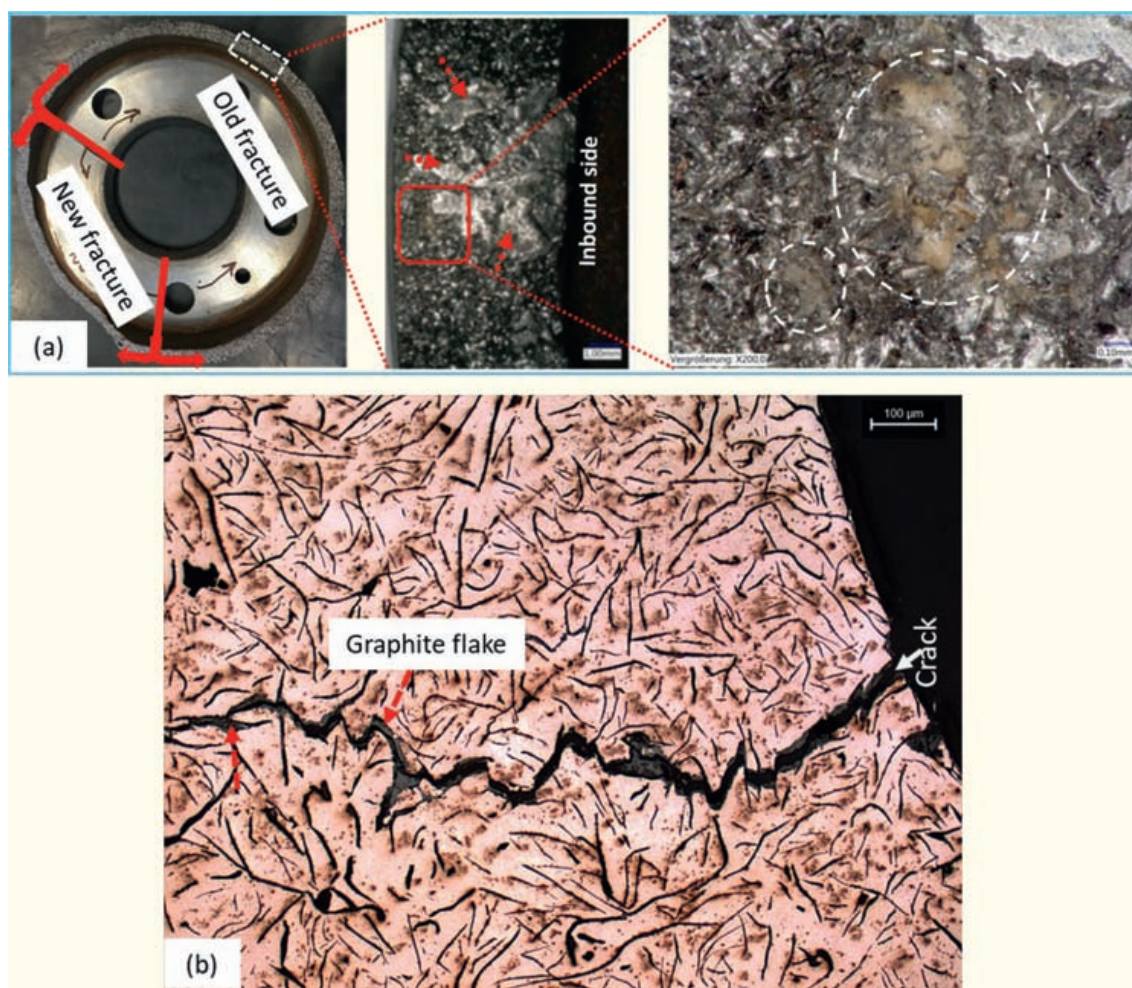
Figure 7.
(a) Stereomicroscope analysis showing fracture surface features. The broken arrows indicate corrosion products; the circled areas indicate foreign structures; and (b) a micrograph showing the propagation of cracks along the graphite-pearlite interface.

products. The region marked with a solid rectangle was further magnified to reveal its microstructural make-up. However, some distinct phases were noticed in the magnified micrograph (areas highlighted in broken circles), which were further examined through an SEM-EDS analysis for identification. Additionally, a metallographic sample was extracted from the region around the fracture and observed under the optical microscope, revealing that the crack, having initiated, propagated circumferentially along the flaky graphite-pearlite interface, as illustrated in **Figure 7b**.

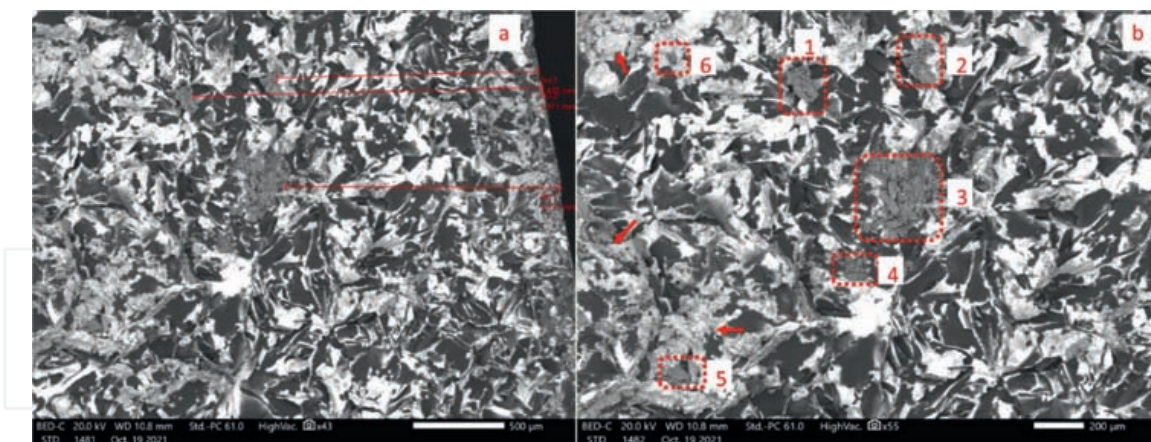
Figure 8.
SEM micrographs of the rotor's fracture surface.

Figure 8 displays the SEM micrographs of the rotor's fracture surface. Different phases with varying textures can be identified from the micrographs. An inspection of the crack surface showed a relatively rough texture with a significant amount of oxidized products and foreign bodies inclusion, as displayed in **Figure 8**. The dark gray is the graphite phase, while the whitish-colored areas are the oxidized pearlite matrix due to the penetration of corrosive agents into the fractured surface leading to the corrosion of the cracked surface. Besides, some areas were recognized with a distinct appearance from the major constituent phases, as shown in **Figure 8b**. These critical features are labeled 1–6 (**Figure 8b**) and further investigated at high magnification to reveal their details. **Figure 9** presents the high magnification of some of the distinct microstructure features identified on the cracked surface of the rotor. A high number of foreign inclusions were also identified, some highlighted in **Figure 8b**. The foreign inclusions occasionally appear as a blocky (**Figure 9**, images 3–6) or lumpy (**Figure 9**, images 1, 2 and 7) structure. The location of the inclusions is approximately 1.620 ± 0.237 mm away from the disc in-board radial perimeter, as indicated in **Figure 8a**. **Figure 8** also displays that the cracked surface portrays layered structures suggesting brittleness, a characteristic fracture behavior exhibited by GCI materials [11, 29]. A network of fine microcracks can be seen on the fracture surface and even in the vicinity of the inclusions (**Figure 8**). Numerous microcracks are observed around these inclusions (**Figure 9**), suggesting potential nucleation sites for crack initiation.

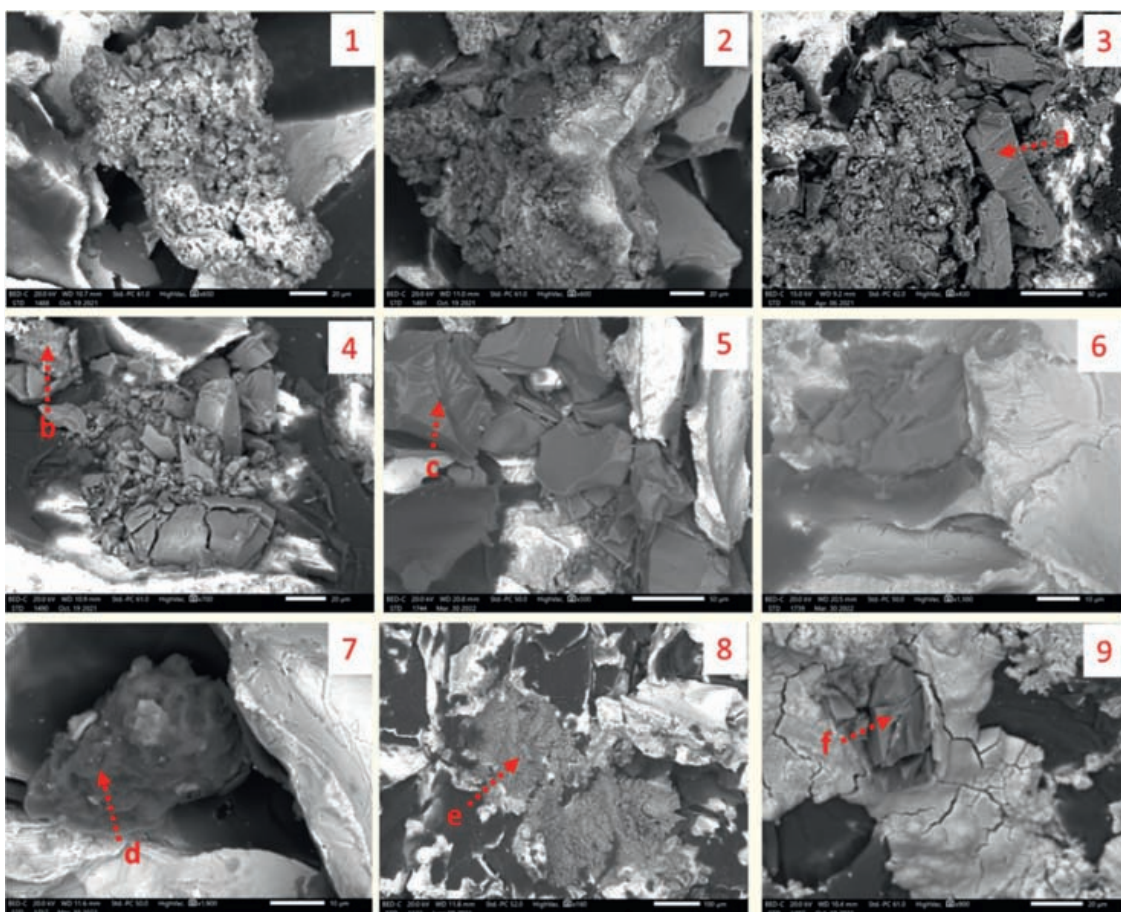
However, an SEM-EDS spot and elemental mapping analysis were employed to identify the origin and composition of the foreign inclusions shown in **Figure 9**. The results of these analyses are presented in **Figures 10–13**. Furthermore, a close examination of the EDS analysis of Spots a and c in **Figure 10** reveals that the foreign materials in micrographs 3 and 5 (**Figure 9**) are silica sand (SiO_2) inclusions. The shape of the sand inclusions is comparatively regular, as seen in the figure. However, some other oxides can be observed admixed with the silica as represented in the EDS microanalysis of **Figure 10d** and the SEM-EDS elemental mapping of micrograph 3 (**Figure 11**).

Figure 9.
 SEM micrographs of the inclusions found on the fracture surface of the rotor.

The SEM-EDS elemental mappings shown in **Figures 11 and 13** depict the existence of chloride ions on the cracked surface of the rotor, which is also corroborated by the EDS microanalysis presented in **Figure 10f**. It can be observed that the chloride ions covered the entire disc's fractured surface, suggesting that the chloride ions possibly originate from an outside source, such as road salt. During winter, calcium and sodium chloride salts are generally used for roadway de-icing, thereby creating a high concentration of chloride ions on the motorways. Salt solution on the road can easily penetrate the crack surface of the rotor (**Figure 4**) and hasten the corrosion of the fracture surface (**Figure 8**). Chloride ions are a highly corrosive agent that serves as a catalyst and exacerbates the deterioration of steel and cast-iron components [11]. Analysis of the disc's fractured surface showed that the rusty products were only noticed in the pearlitic matrix areas, as displayed in **Figure 9**, micrographs 6–9, since graphite does not corrode.

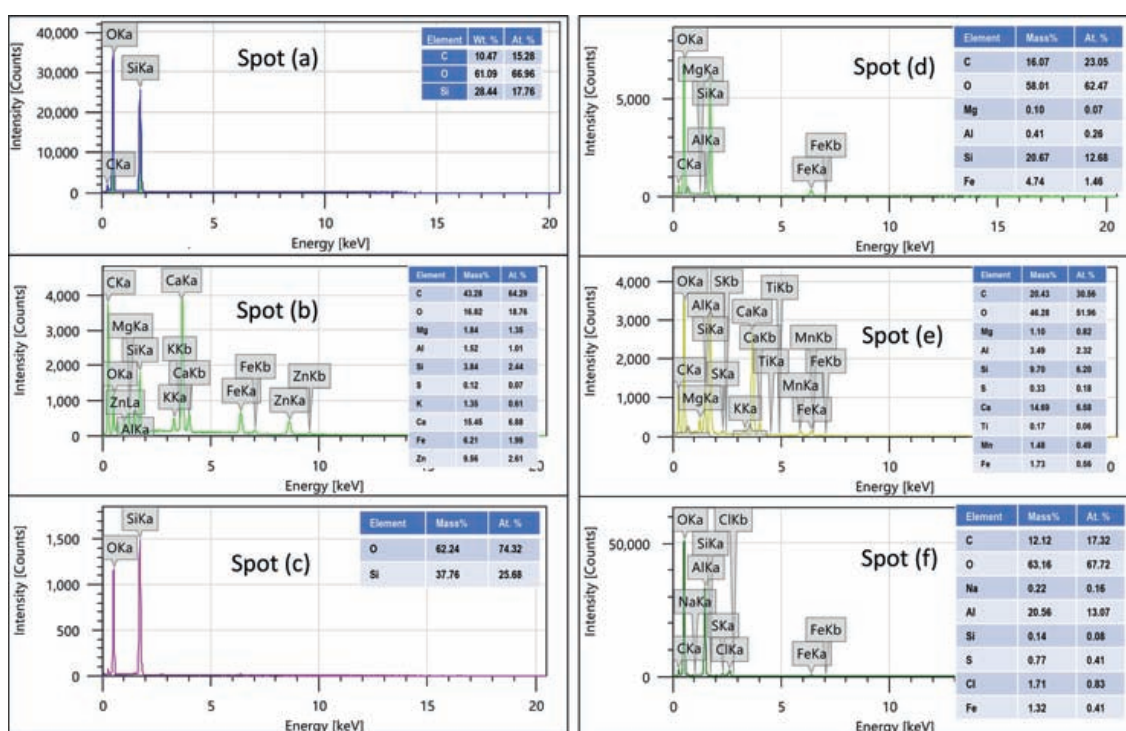
Figure 10.
 SEM-EDS spectra of spots (a-f) indicated in Figure 9.

material. By analyzing the EDS microanalysis of spots b, e-f (**Figure 10**) and comparing it with the elemental mappings shown in **Figure 11** (micrograph 1) and 12 (micrograph 7), it can be seen that some of these lumpy inclusions are the oxides rich in calcium, silicon, zinc and aluminum with traces of admixture oxides of Mg, Ti, Mn, Na, K and Fe. The analysis also reveals minor phosphorous, sulphide and chloride concentrations (**Figure 10b, e, f, 11 and 13**).

The fractographic examination conducted on the failed rotor has identified indigenous and exogenous inclusions on the disc's cracked surface. The inclusions from external sources like slag, dross, ferroalloys, flux materials, ladle lining, and entrapments from eroded mold, core and refractory materials are categorized as exogenous. Those native or inherent in the molten metal treatment process are known as indigenous inclusions. Indigenous inclusions are the products of the liquid melt reactions with deoxidizers such as silicon, manganese, and aluminum particles or during desulphurization, creating some residual oxide inclusions in the casting [22]. However, previous studies have recognized ferroalloys as a significant source of inclusions in steel and cast-iron castings [11, 30]. Ferroalloys are pre-alloyed raw materials bonded with iron used in the treatment of molten iron and steel to produce castings with desired chemical composition. In general, the primary applications of ferroalloys in iron and steel makings include (i) alloying sources to enhance the mechanical properties and functional characteristics of iron and steel products (e.g., FeCr, FeMo, FeTi, FeMn, FeW), (ii) deoxidizers such as FeSi, FeMn, SiMn and FeAl, and (iii) reducing agents such as FeSi which can be used as a reducing agent to produce FeMo, FeV and other alloys [30]. Unfortunately, several impurities accompanied ferroalloys production, including H, N, O, S and P and other trace elemental impurities such as Mg, Al, Ti, V, Ca, etc. In the cast-iron melting process, FeSi ferroalloys are the common source of silicon addition to the molten iron to decrease its melting point, improve fluidity, and promote graphitization. These FeSi alloys are the source of Al and Ca impurities, which can significantly affect the quality of the castings by forming oxide inclusions. Unfortunately, these inclusions provide excellent nucleation sites for microcracks during cooling, which is why they were consistently found within microcracks [30]. Earlier studies [31] have shown that the predominant composition of slag formed from spheroidal and lamellar irons processing consists of several oxides, including FeO, MnO, SiO₂, Al₂O₃ and MgO. In a similar investigation, Jonczy [32] concluded that the dominant component of the cast iron slag is silica (62.04%) in addition to 11.03% of Al₂O₃, 10.38% of MnO, 6.32% of MgO, 5.37% of CaO with the admixture of iron, sodium, potassium, barium and sulfur oxides. The chemical composition of slag can vary greatly depending on the level of impurities in the starting raw materials (e.g., pig iron and scraps) and other additives (e.g., flux agents and ferroalloys). For instance, the slags formed using steel scrap-based charges showed the highest zinc and aluminum contents and created a crystalline ZnAl₂O₄ (gahnite) phase in addition to other admixture oxides (e.g., SiO₂, Al₂O₃, CaO, MgO and MnO). These high zinc and aluminum contents are due to the use of galvanized steel scrap as raw material (Zn and potentially Al) and of FeSi and SiC as additives (Al) [31]. This probably explains the high concentrations of Zn, Al and Ca found in some of the inclusions identified in **Figure 10(b, e and f)**.

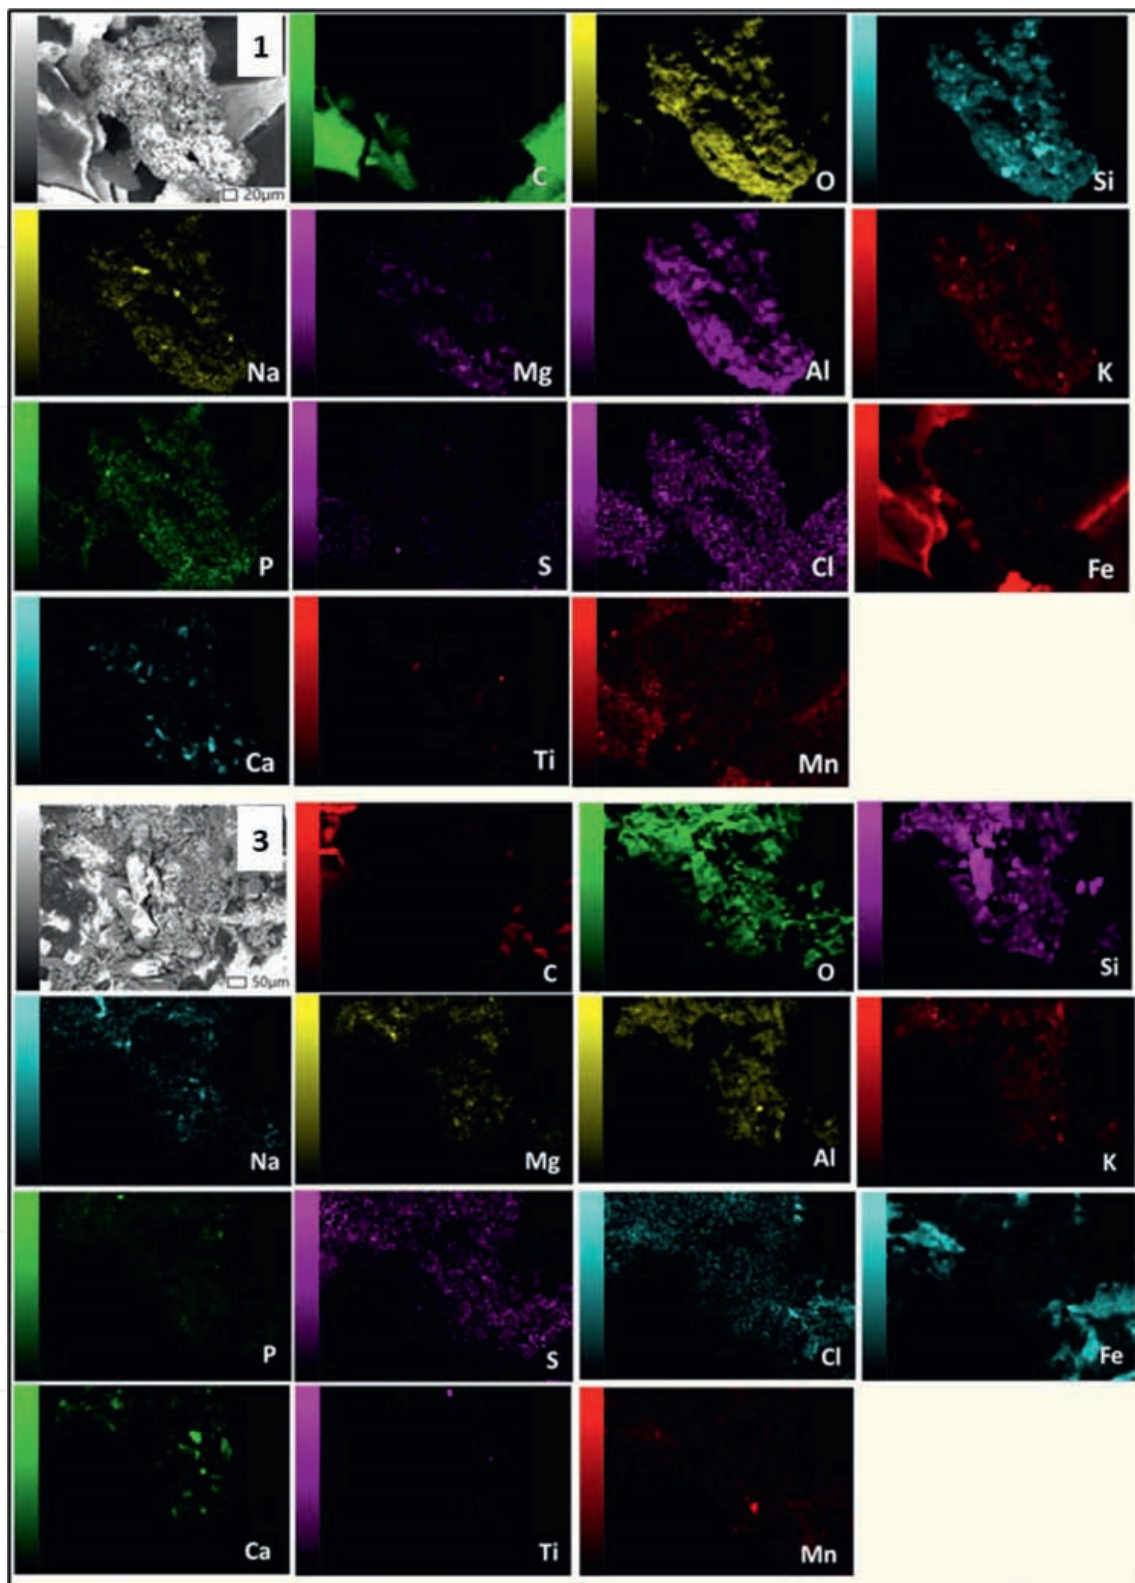
Figure 11.
SEM-EDS elemental mapping of micrographs 1 and 3 of Figure 9.

Silica sand with binders is generally used for making mold and core in the iron casting process and can be differentiated from slag because it comprises a single phase (**Figure 10a** and **c**). The presence of silica inclusions can be attributed to the entrapment of mold material during metal pouring due to the erosion of or loose mold

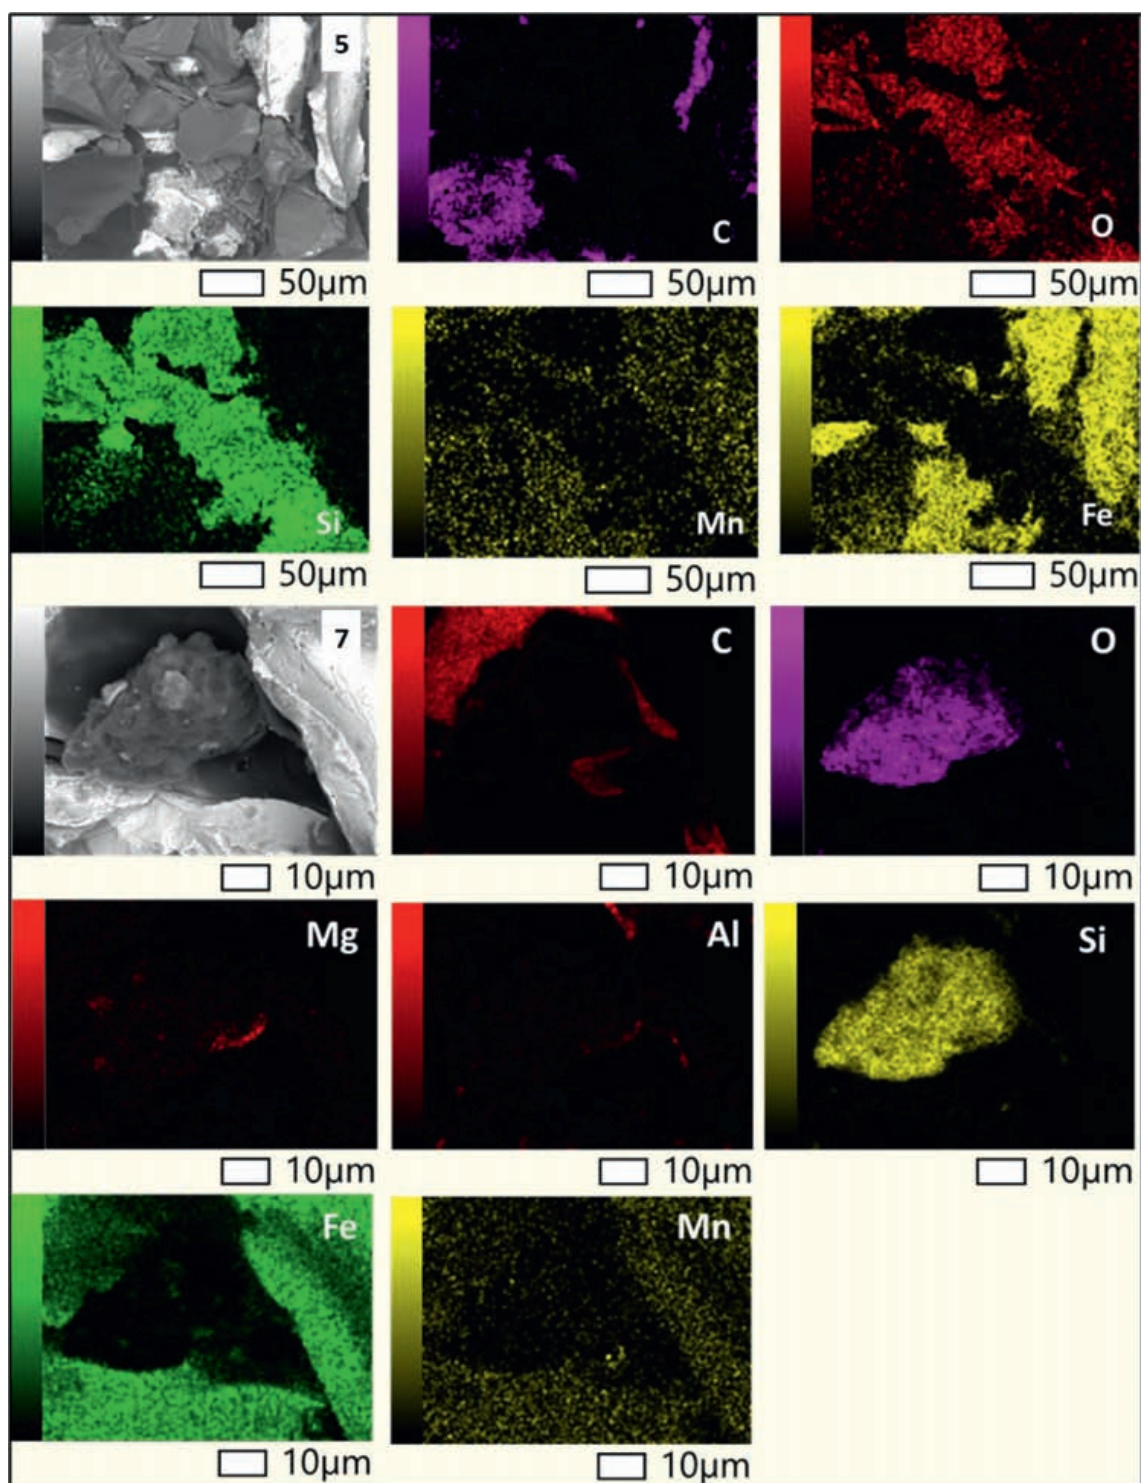
Figure 12.
SEM-EDS elemental mapping of micrographs 5 and 7 of Figure 9.

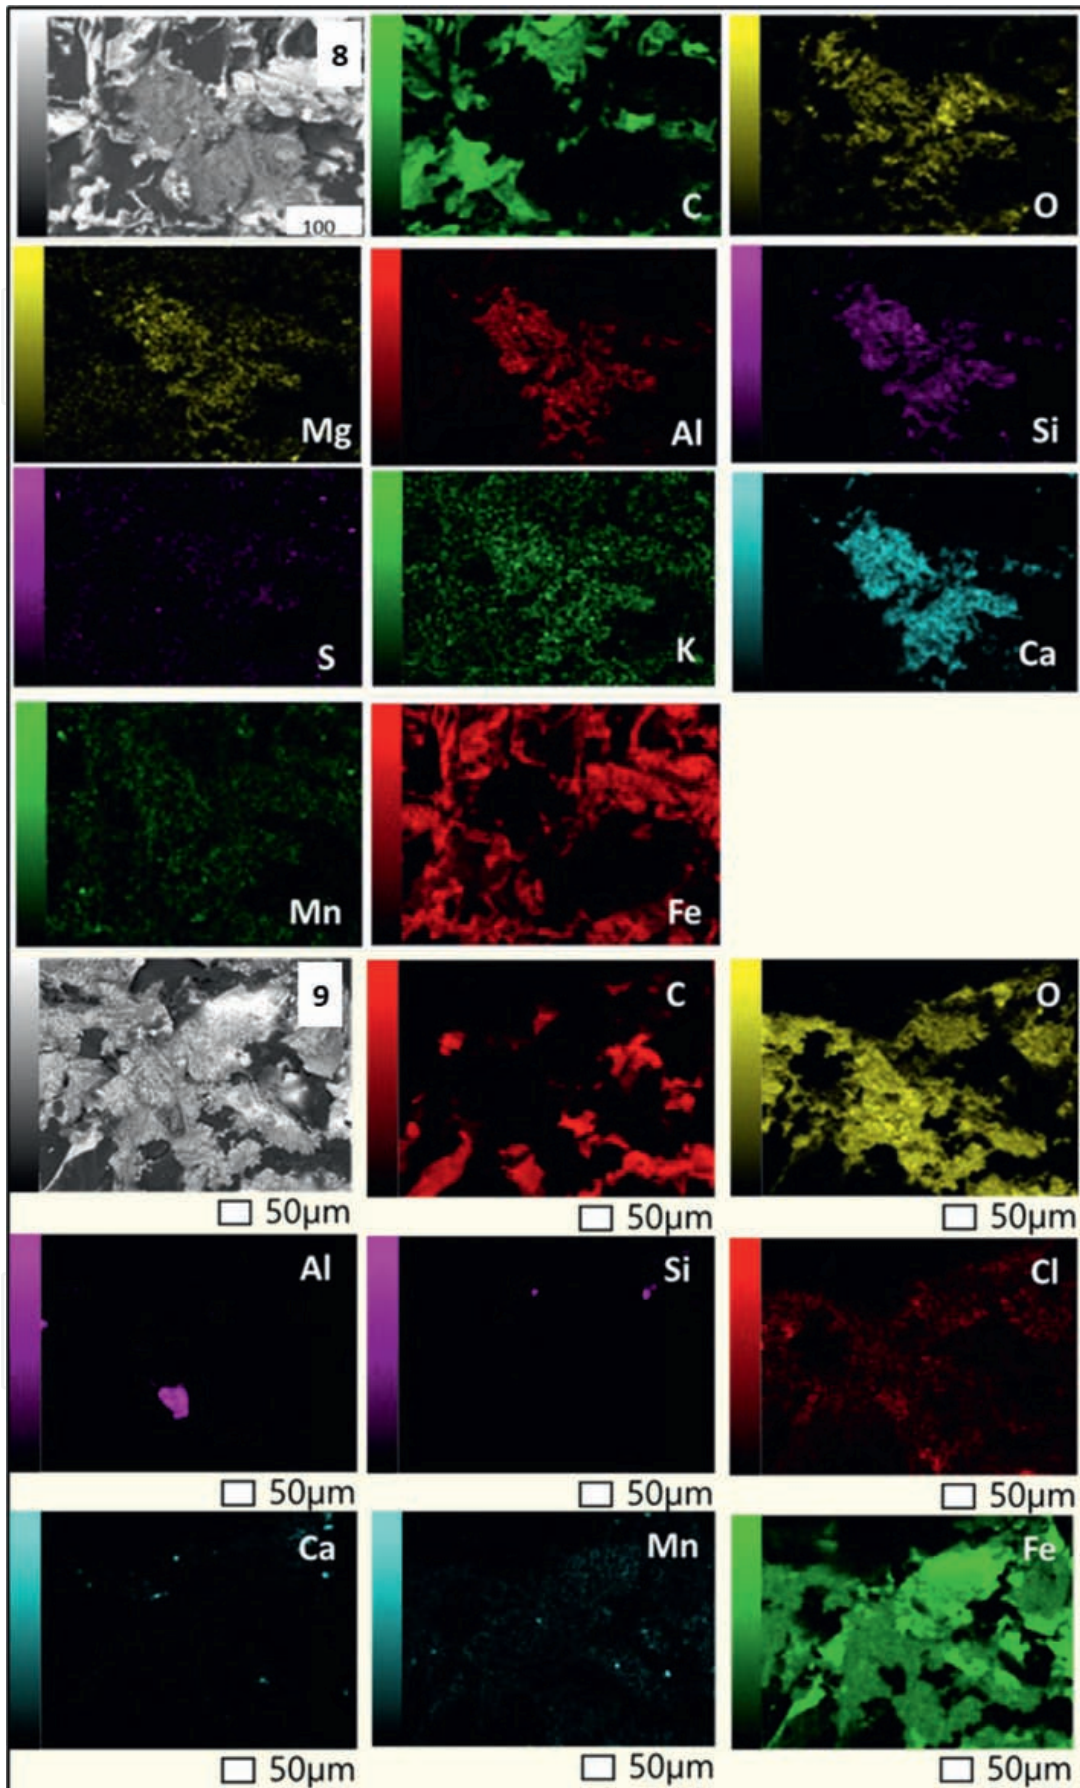
Figure 13.
SEM-EDS elemental mapping of micrographs 8 and 9 of Figure 9.

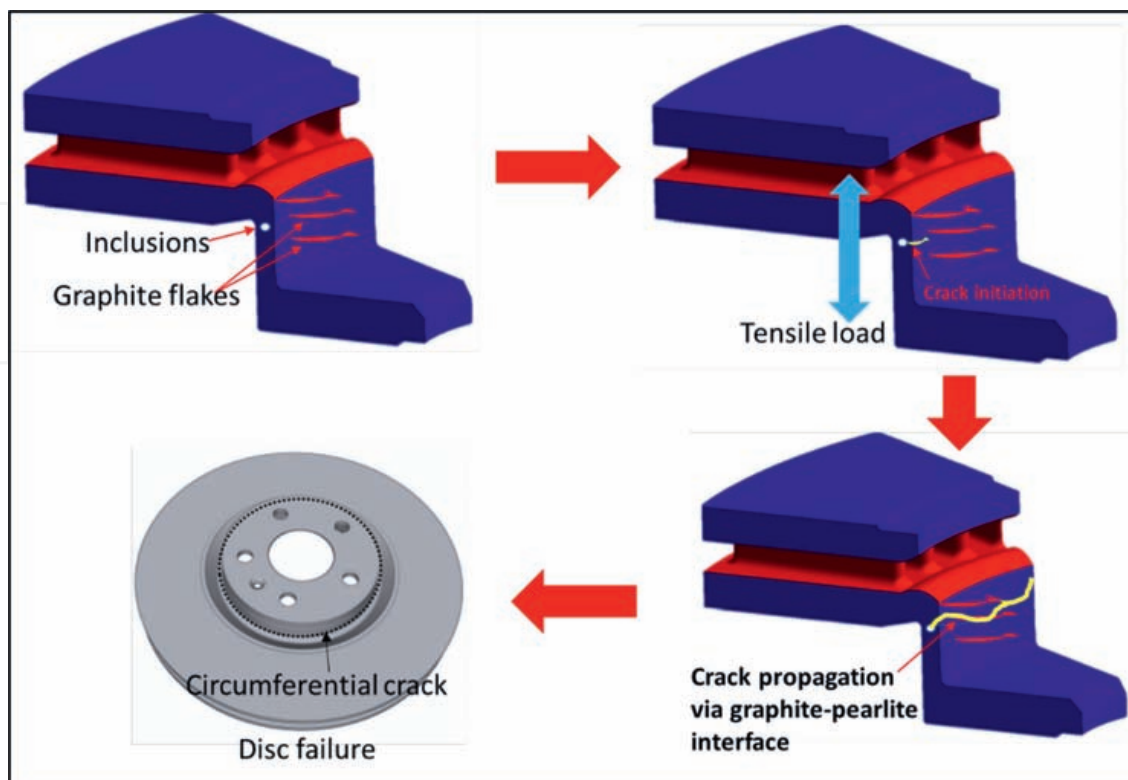
As illustrated in **Figure 14**, nonmetallic inclusions in the rotor's swan neck reduce the disc's adequate thickness. The design thickness in the rotor neck region is 6.62 ± 0.01 mm, but the inclusions defects were positioned at approximately 1.620 ± 0.237 mm away from the rotor inner radial perimeter. During the braking regime, the disc swan neck can be exposed to cyclic compressive or tensile loads (**Figure 14**). However, inclusions in the neck region would reduce the swan neck's design load-bearing capacity, consequently

Figure 14.
A schematic illustration of the mode of failure of the rotor.

subjecting this region to higher stress during service. Due to the high thermal expansion potential of the inclusion particles, they would disintegrate into smaller particles [11, 35] and produce cavities that generate microcracks around the inclusion particles (**Figure 9**). Also, during the application, the brake rotor continuously experiences thermal (heating and cooling) and mechanical loadings that cause local concentrations of strain, induce residual stresses and initiate microcracks because of the thermal expansion mismatch between the inclusion particles and the pearlitic matrix. These microcracks propagate further through the interface between the graphite-pearlitic matrix (**Figure 7b**) and ultimately cause the rotor's failure.

After understanding and establishing the failure root cause(s), it is essential to formulate corrective or preventive measures/actions to forestall future recurrence. Judging from the various inspections performed on the failed rotor, the outcomes indicated that the inclusions (sand and slag materials) embedded in the rotor's swan neck during the casting process were responsible for its premature failure. This observation indicated that the failure root cause originated from the rotor manufacturing, implying that the preventive recommendations should be focused on the casting process to ensure quality castings. Therefore, the following strategies should be strictly implemented and practiced by the metal casters for casting quality enhancement and to avert nonmetallic inclusions during the following casting operations.

- i. **Mold design and preparation:** Good gating design and adequate compaction of the molding sand during mold preparation are the initial steps to ensure quality casting. However, the gating system and the mold cavity should be free of sharp corners to minimize erosion wear. When assembling the mold, any loose sand particles around the down sprue or at the bottom of the sprue should be eliminated to prevent sand entrapment during mold filling.

- ii. **Melt preparation and pouring:** Melt cleanliness is paramount to sound castings. Metal casters should implement a comprehensive approach to preventing slag particles from getting entry into the mold cavity by using suitable purifying additives (fluxing and floating agents) that protect liquid iron from further oxidation during melting and allow the slag to flow on top of the molten iron for easy removal before the pouring operation. A ceramic screen should be integrated into the gating system to separate slag material from entering the mold during melt pouring. Besides, a bottom-poured ladle should be used to eliminate slag entrapment. Melt pouring should be done to minimize turbulent flow during mold filling.

- iii. **Quality control management:** Metal casting is a complex process that requires standard quality assurance management. A poorly managed quality control system in the foundry industry would impair the quality of castings. Therefore, metal casters should rigorously inspect the quality of all the casting processes and castings to diminish products' imperfections. An in-line nondestructive evaluation (NDE) solution (radiographic and ultrasonic inspections) should be developed and implemented in the foundries for the early discovery of cast imperfections such as nonmetallic inclusions, gas porosity, cracks, shrinkage porosity, and other casting irregularities to ensure a 100% quality assurance of their products. Continuous training of foundry workers regarding quality inspection in all facets of casting operations should be implemented, and negligent attitudes among foundry workers should be discouraged.
