# The impact and resolution of the GPS week number rollover of April 2019 on autonomous geophysical instrument platforms

Shane Coyle<sup>1</sup>, C. Robert Clauer<sup>1,2</sup>, Michael D. Hartinger<sup>3</sup>, Zhonghua Xu<sup>1,2</sup>, and Yuxiang Peng<sup>1</sup>

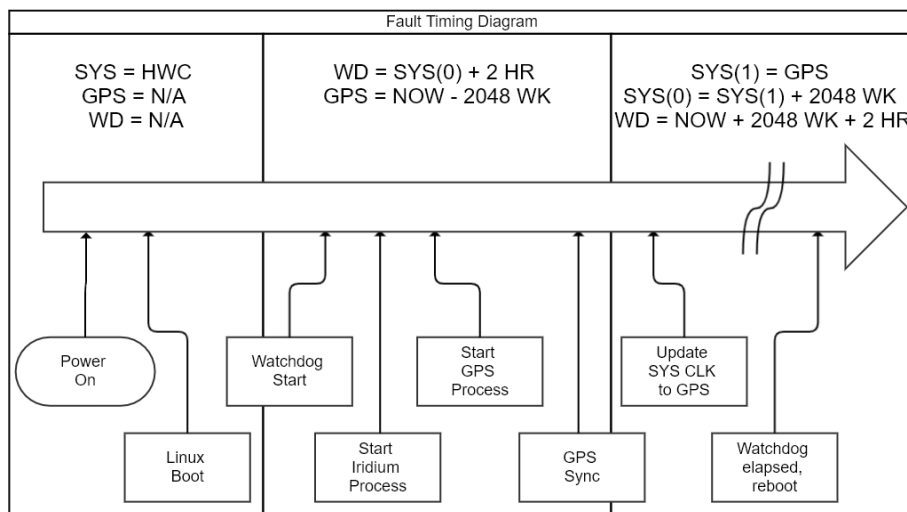
During simulated operational testing of the hardware on-site in Blacksburg, VA, it was determined that the GPS module was providing an erroneous date and time. A constant negative offset of 2048 weeks was found, which is consistent with the GPS rollover period. Further analysis discovered the source of the communications fault, which occurs as a result of updating the system time while an active communications link is established. A communications watchdog is supposed to monitor unusual circumstances relating to “hung” or stalled communications links, but the watchdog relies on the system clock and is effectively disabled because of the bug. The process of determining how much time has elapsed between successful communications attempts is a simple subtraction of a watchdog start time from the current system clock time. However, when the system time went through its update process, it set the system clock back 19 years, and the subtraction to determine the elapsed time yielded a negative result. In the case of the AAL-PIP watchdog, an elapsed time of 2 h without successful communications will trigger the watchdog. For the bugged negative result to ever reach that threshold after the fault occurs would take 19.6 years and 2 h. This process of updating clocks and watchdogs is illustrated in Fig. 2.

**Figure 2.** Diagram showing the process of updating the multiple clocks on an AAL-PIP. After the Linux OS finishes initialization, the AAL-PIP software sets the watchdog (WD) timer and spawns separate processes for communication and GPS synchronization. In this diagram, SYS(0) refers to the value of the system clock after boot, whereas SYS(1) is the system clock value after GPS sync. The fault occurs in block three, where the system clock SYS(1) is set to the erroneously offset GPS time.

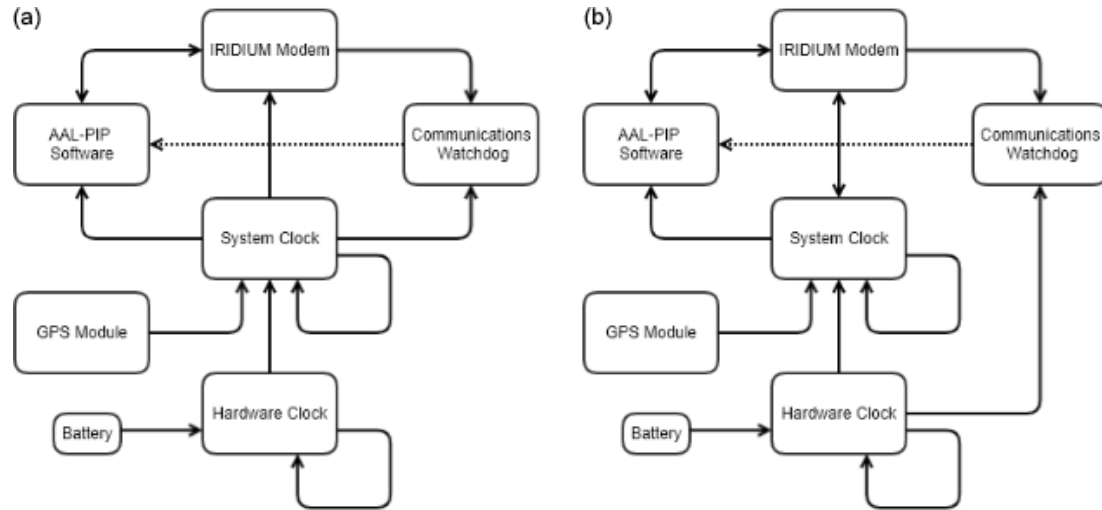
**Figure 3.** Diagrams contrasting the original flow of time information on the AAL-PIP systems (a) with the current method (b). Note the use of the hardware clock as an input for the communications watchdog, as well as the availability of Iridium network sourced time for the system clock. The dotted line represents a reset signal presented by the watchdog.

Determining the source of the fault was a crucial first step in restoring the operational status of the AAL-PIP array. Following the fault isolation, it was necessary to develop a software patch that addressed the rollover related time setting bug. There were two important issues to resolve in writing any potential solutions. First, because of differences in GPS firmware, determination of whether the bug was present had to take place. It was noted that one remote system had not entered the fault state, and it is suspected that this is because it was built several years after the initial platforms. Likely, this later GPS module had a firmware update that could handle the rollover. Isolating fault occurrence was achieved by first determining if the reported date was prior to the current GPS epoch start date. Second, if the date was incorrect, the reported difference in date and time had to be offset, in this case by simply adding a constant value to the recovered value. This software patch was developed in December 2019 in advance of the austral summer field season. Figure 3 shows the differences in timing information flow within the AAL-PIP systems as a result of this patch. The first attempt to deploy

In the case of the AAL-PIP system, there are two important software design considerations that had to be addressed during the patch process. First, the communications watchdog timer issue had to be resolved. Typically, the watchdog will automatically reboot the system after either staying connected or disconnected for more than 24 h. When the watchdog first starts, it obtains the current time and then sets a trigger for 24 h later. This reboot process was prevented by rolling the clock back to a time several years before the trigger time. A different, more robust solution to using the full date and time for timers like this would have been to strip the date from the trigger. However, this can still lead to some confusion as a result of making adjustments to the system clock. Using a monotonic hardware clock for this timer would provide a more robust solution, as these clocks typically are not adjusted by any software process.
