Application of Risk Analysis Methods on Tailings Dams

T. Espósito, L.R. Palmier

Keywords: tailings dams, risk analysis, LCI, LCI MOD-REJ, FMEA, safety management.

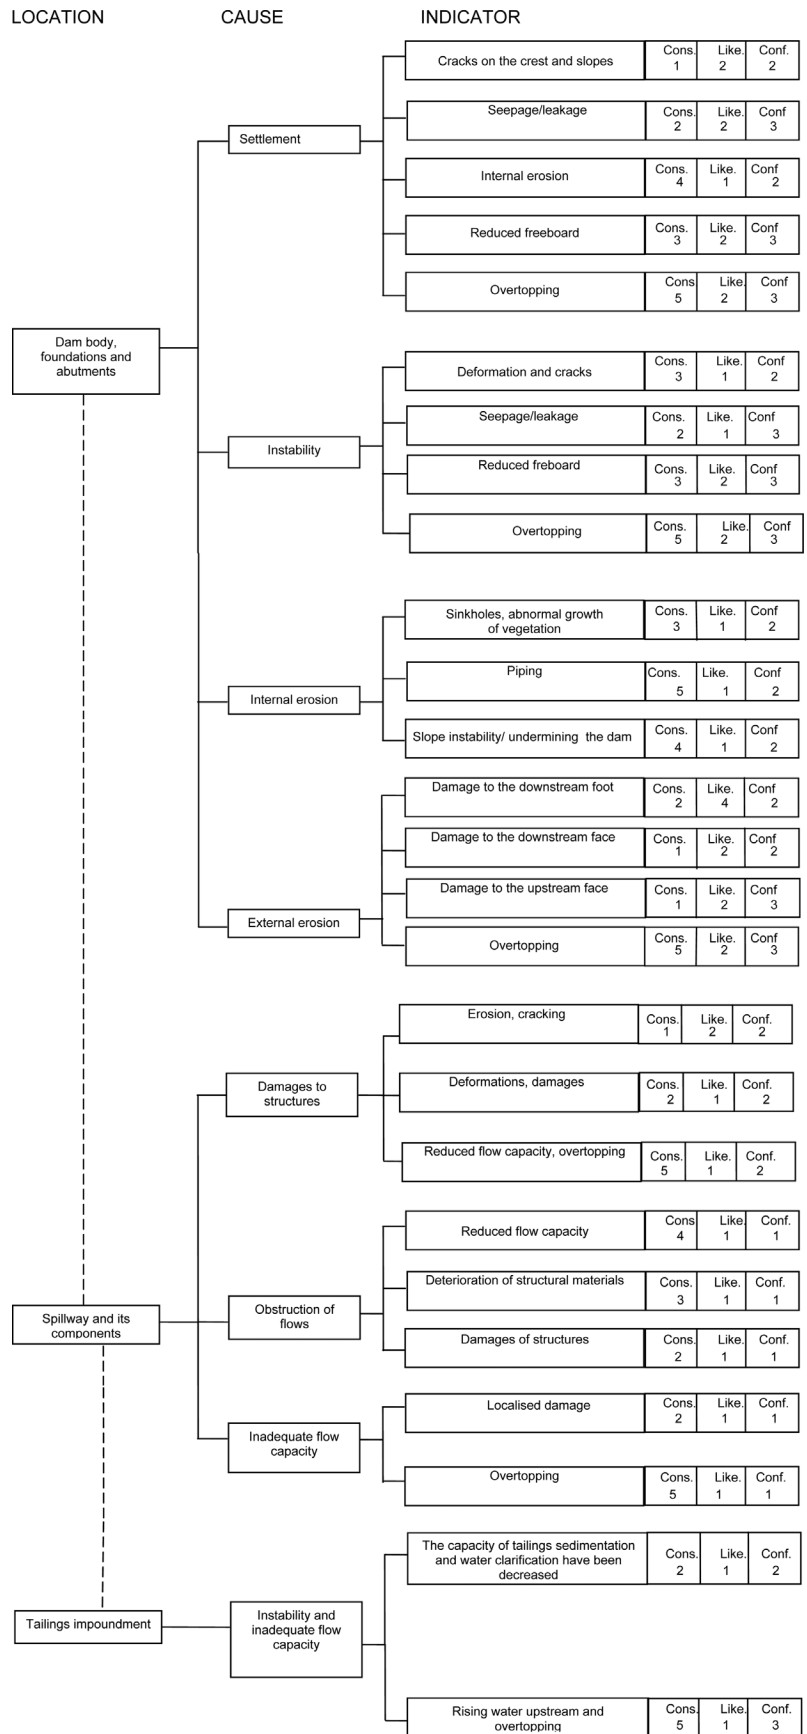
The causes and indicators were classified according to three attributes (Figs. 1 and 2): Consequence (Cons.); Likelihood (Like.); Confidence (Conf.).

Figure 1 - Diagram LCI MOD-REJ Tailings Dam A - Attributes Consequence (Cons.), Likelihood (Like.) and Confidence (Conf.).

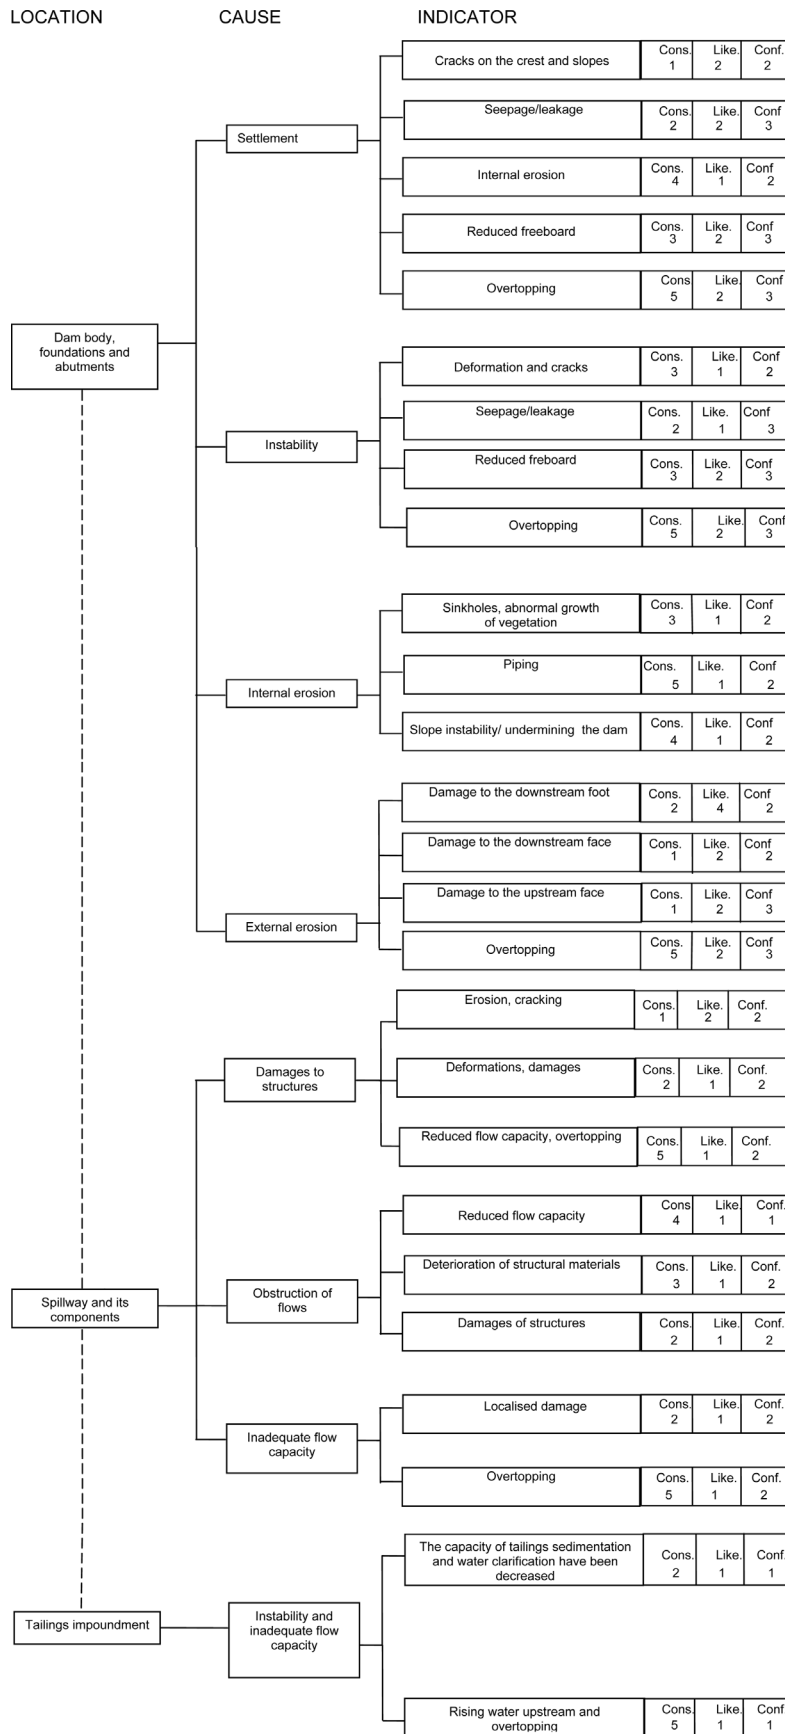
Figure 2 - Diagram LCI MOD-REJ Tailings Dam B - Attributes Consequence (Cons.), Likelihood (Like.) and Confidence (Conf.).
