PROGRAMME AND ABSTRACTS

TechnoHeritage 2017

Cadiz, Spain 21-24 May 2017

Programme and Abstracts

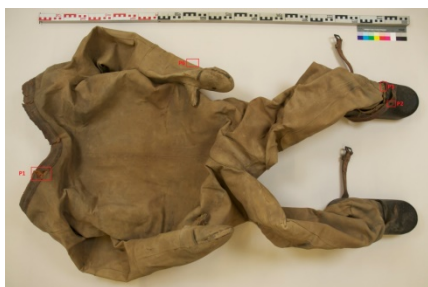
Fig. 1. Diving suit. (Picture: J. Fey)

The study allowed discovering a range of caoutchouc materials used in the diving suit with different purposes, and produced with a range of manufacture processes using different additives, as seen e.g. in REM-EDX. Caoutchouc could be found as lining in waterproofing layers in the textile (Fig. 2), as sealing material in the helmet and in three-dimensional caoutchouc elements.

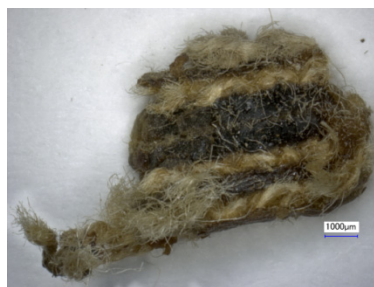
Fig. 2. Cross-section of a sample from the diving suit.

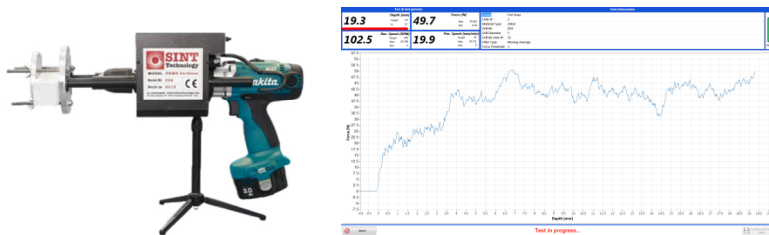
A dedicated software performs a real-time data acquisition from the instrument and provides advanced features for data analysis. The software also produces filtering functions in order to separate the desired signal from the noise (drill bit rotation, vibrations, etc.). After the data acquisition, it's possible to elaborate each hole result in relation to the other measurements acquired by the software.

The Drilling Resistance Test Method can be used for the characterization of historic masonry materials, both on site and in laboratory. It allows to obtain detailed information concerning the mechanical properties of materials and to evaluate, for example, the performance of consolidation treatments. The test consists in drilling a small hole at a set constant rotational speed and penetration rate in order to measure drilling force versus depth. The Drilling Resistance Measurement System (DRMS) is an useful portable tool that continuously measures the required force to drill the hole in the investigated material during all the testing process.

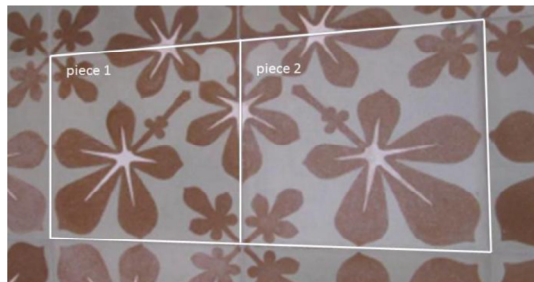
Figure. Hydraulic mosaic tiles, piece 1 without discoloration and piece 2 with discoloration.

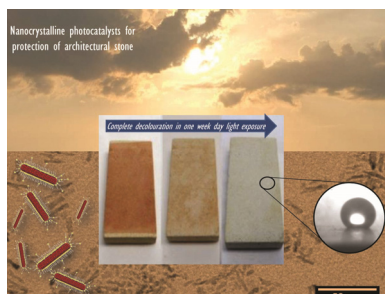
Figure 1: Bleaching of Methyl Red dye on PL surface treated with TiO₂ NR after 1 week exposure to day light. Inset: Water contact angle highlight the hydrophobicity of the treated surface.

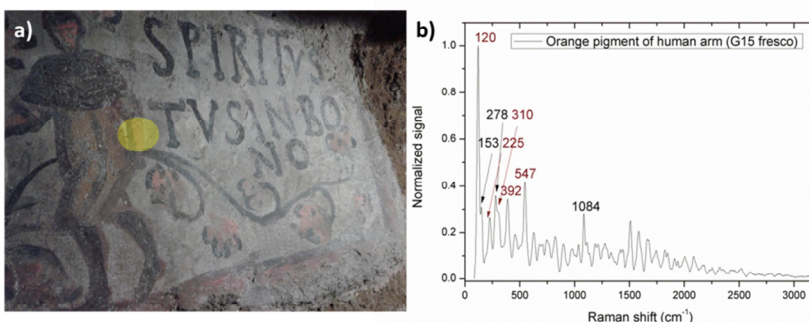
Figure 1. a) Portion of the G15 fresco inside the catacomb with one of the scanned area (in yellow). b) Raman spectrum of the analysed pigment (minium + calcite).

Pigments like red ochre, yellow ochre and minium were detected after scanning the coloured areas for few tenths of seconds (Fig.1), whereas calcite was detected as pictorial background material. Further information on any surface contamination by organic residues, salt deposits, or the presence of consolidating substances (Primal, Paraloid) were obtained with the synergistic use of LIF (laser-induced fluorescence) spectroscopy, another non-destructive, contactless, laser-based technique that allowed to clearly identify large areas subjected to conservation treatment and localize the presence of any contaminant.

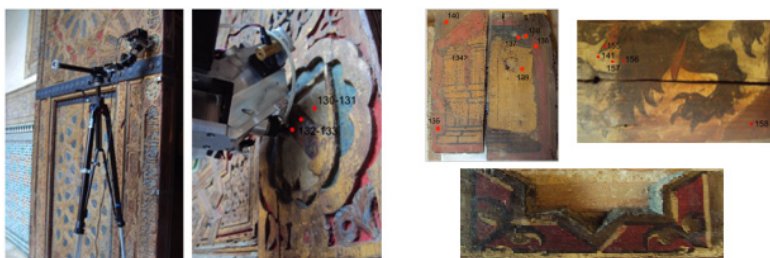
Figure 1. Photos of some zones of the carpentry studied in this work.

The study of the polychromy from *Cuarto Real Alto* revealed yellow ochre, vermilion and azurite respectively for yellow, red and blue colours. Bone and carbon black have also been used as well as gypsum and lead white for white and/or ground. The analysis made on the metallic sheet showed high amount both iron and gold, which suggested that, this sheet was made with gold leaf on bole (above a gypsum ground).

In the doors of *Patio de las Doncellas*, in addition to those pigments, green colour was obtained with a copper pigment. More interestingly XRF analysis on the blue colour showed the presence of Si, Al, Na, S and K characteristic of artificial ultramarine blue. XRF analysis performed in situ showed that the leaf adhered to the surface is composed of gold, copper, silver and zinc. Besides, the presence of lead chromate showed that the actual gilding was realized after the year 1818. The presence of such pigments that was discovered and applied in 19th century confirmed that the paints were not original and had been changed during the restoration performed in 19th century in the Alcázar. This pigment (lead chromate, yellow chrome) was used either as the mordant, under the gold layer or as false gold. The data stressed important differences between the two studied carpentry attributed to the application time.

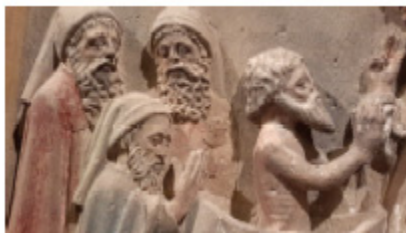
Detail of the *Passio Imaginis* Altarpiece.

The characterization of the polychromies began with an organoleptic examination and photograph of general visible light and flush, assessed by digital image analysis (DIA). DIA allowed revealing traces of polychromies that had not been detected by naked eye in order to carry out the proper sampling. The samples were analyzed by optical microscopy; scan electron microscopy (SEM-EDX), and the study of organic binders.

The results obtained in the stratigraphic studies revealed the application of a sequence of layers of calcite and/or albayalde preparation. The pigments identified were vermilion, azurite or lapis lazuli; these pigments do not provide data on the chronology but coincide with medieval symbolism of colour and pigments employed in Iberian Peninsula. Binders detected are egg or animal glue. Data indicates that it is most likely an original finish.
