Root Cause Failure Analysis of Castings: A Case Study of a Brake Rotor

Samuel A. Awe

Abstract

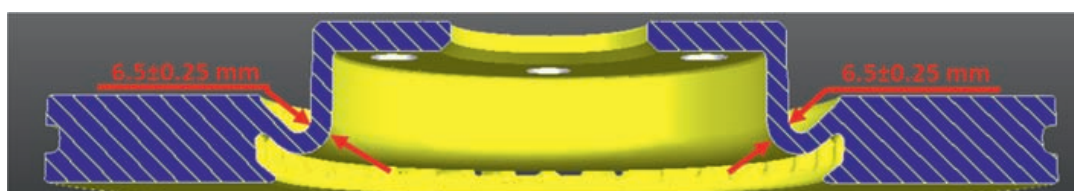
Figure 5.
A schematic representation of the rotor showing the specified swan neck thickness.

During the casting operation, a core shifting may occur, which could alter the dimensional correctness of the disc swan neck thickness. Therefore, inspecting the correctness of this thickness is sometimes crucial to avoid a reduction in load-bearing capacity. A core is a pre-determined shape of the mold, which provides internal cavities, recesses, or projections in the casting. The tendency for core instability during the casting operations is high due to pressure build-up or operational error during the mold filling. A core shift is a defect due to the buoyancy of liquid metal that causes the core of the cast to move from its correct position. If a core shift occurs, it causes a dimensional inconsistency in the casting. **Figure 5** shows a schematic illustration of the brake rotor suggesting the design requirement of the rotor swan neck thickness. As indicated in the figure, the specified thickness is 6.5 ± 0.25 mm. The failed disc swan neck thickness was determined as 6.62 ± 0.02 mm, which is still within the design specifications. This analysis suggests that the failure was not caused by core shifting.
