Uneven illumination surface defects inspection based on convolutional neural network

Hao Wu *, WenbinGao, and Xiangrong Xu

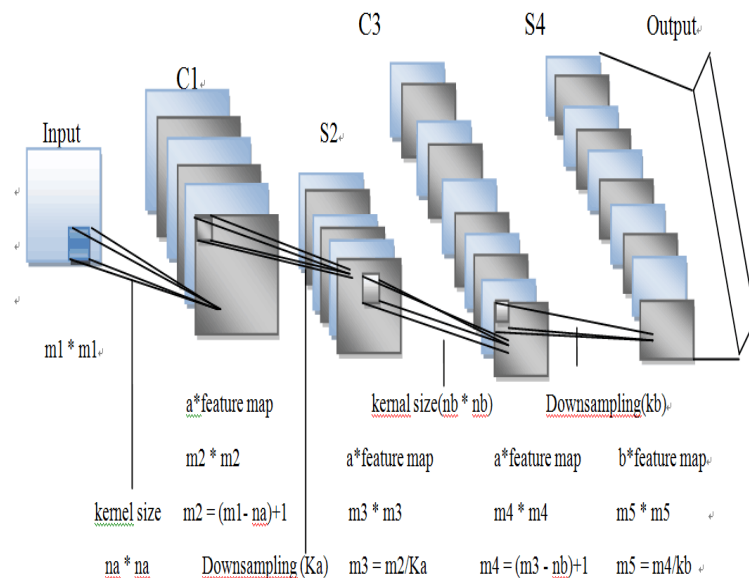
LeNet-5 is one of the convolutional neural networks [18], and its structure is shown in Figure 1: LeNet-5 structure were seven layer structure. First as the input layer of input, then C1 is the convolution layer, which contains a Four feature map, the convolution kernel size is $n_a \times n_a$, and the feature map size after the convolution operation is $m_2 \times m_2$. S2 Sampling is the next layer, comprising feature image with number of a, each feature in C1 neurons corresponding features of $n_b \times n_b$ local neighborhood as input. C3 is also a convolution layer, a feature maps has the size of $m_4 \times m_4$. S4 is the downsampling layer, including b feature maps, each of the neurons in each feature map of S4 corresponds to C3 feature map. Subsequent to S4 is a fully connected layer containing neurons. The final output layer consists of radial basis functions used to identify defects.

Figure 1. Convolutional neural network structure

The experiment platform is run on MacBook air notebook with 8GB of memory computer, this paper build the convolutional neural network, which is similar to convolutional neural network LeNet-5, this convolutional neural networks has two convolution layers and two pooled Layer. And it is trained in the number of different numbers. Then test it.

The input image height and width are 400×400 (ie, image pixel 400×400), and the first layer of convolution kernel is 3×3 , convolution layer c1, get 6 feature maps of size 398×398 , the downsampling coefficient is 2, the downsampling

layer S2 gets 6 sizes of 199×199 Feature map of 199 , the second layer of convolution kernel size is 3×3 , convolutional layer C3 gets 12 sizes of 100×100 feature map, the downsampling coefficient is 2, the downsampling layer S4, get 12 sizes of 50×50 feature map. The output layer is 2 due to classification and defect.

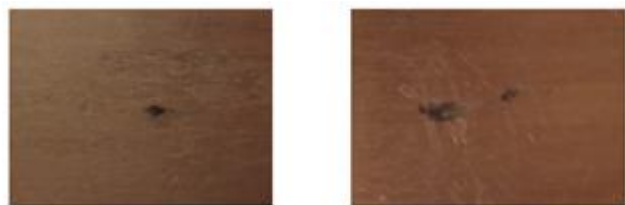
Firstly, collect a set of surface images such as copper strip image image samples, including 30 training images, where the normal number is 15, the defective number is 15. And 30 test images, 15 of which are normal and others defective. For simple defects such as inclusions, pits, and flaking, the defect images are shown in Figure 2: where these defects are obvious, the right part area is darker than the left area, that is, they are affected by uneven illumination.

Figure 2 Defect copper image samples

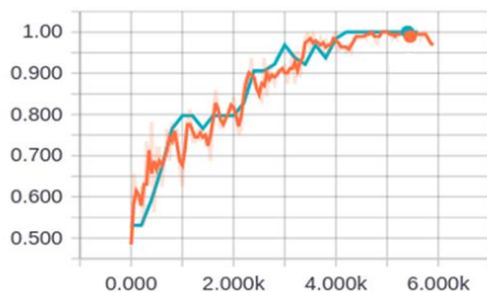
It can be clearly seen from Fig. 3 and Fig. 4 that at the beginning of training, the loss function is about 0.6 and the correct rate is about 0.5. As the number of training steps increases, the loss function gradually decreases, and the correct rate gradually increases. When it reaches 2000, the loss function is about 0.5, and the correct rate is about 0.8. When the number of training steps reaches 5000, the loss function has been reduced to about 0, and the correct rate is close to 1. Therefore, according to the displayed results, the model for classifying the copper strip image defect inspection and identification is satisfactory. Therefore, the trained model is saved, and then the selected model is tested on the trained model.

Figure 3 correct rate change curve: training set (orange) and verification set (blue)

Since the two-layer convolution is relatively simple, we set the number of training steps to 5000 for the first time. Based on the computer configuration, and there is no GPU built, the training is cost for 2 hours, and the correct rate and loss during the training. The function changes are shown in Figure 3 and Figure 4 below. The orange and blue curves represent changes in the training set and the validation set, respectively.

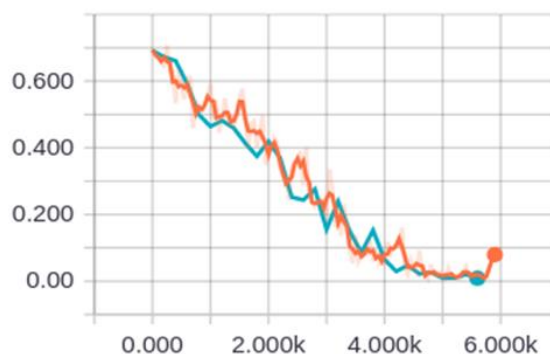
Figure 4 loss function curve: training set (orange) and verification set (blue)

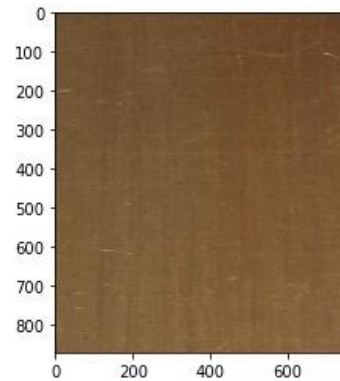
This is a OK with possibility 0.67436

Figure 5 Qualified sample test results

It can be seen from Figure 5 that there is no defect in the image of the copper strip image tested, it is a complete good copper strip image, and the result of the experimental model output "this is OK with possibility 0.67436", it is also a correct determined for the copper strip image. The probability of judgment is approximately 0.674. The judgment is correct.

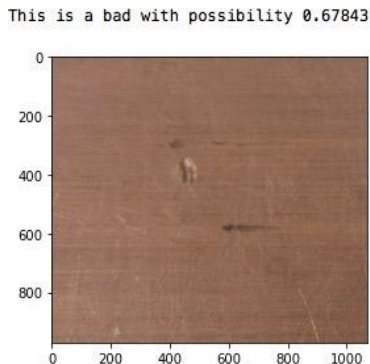
Furthermore, there are obvious defects in Figure 6. The test results show that the possibility of the copper strip image being defective is 0.678. Thus, the judgment result is correct. After several consecutive tests, the experimental results were the same as above, and no judgment errors occurred.

Figure 6 Defective sample test result

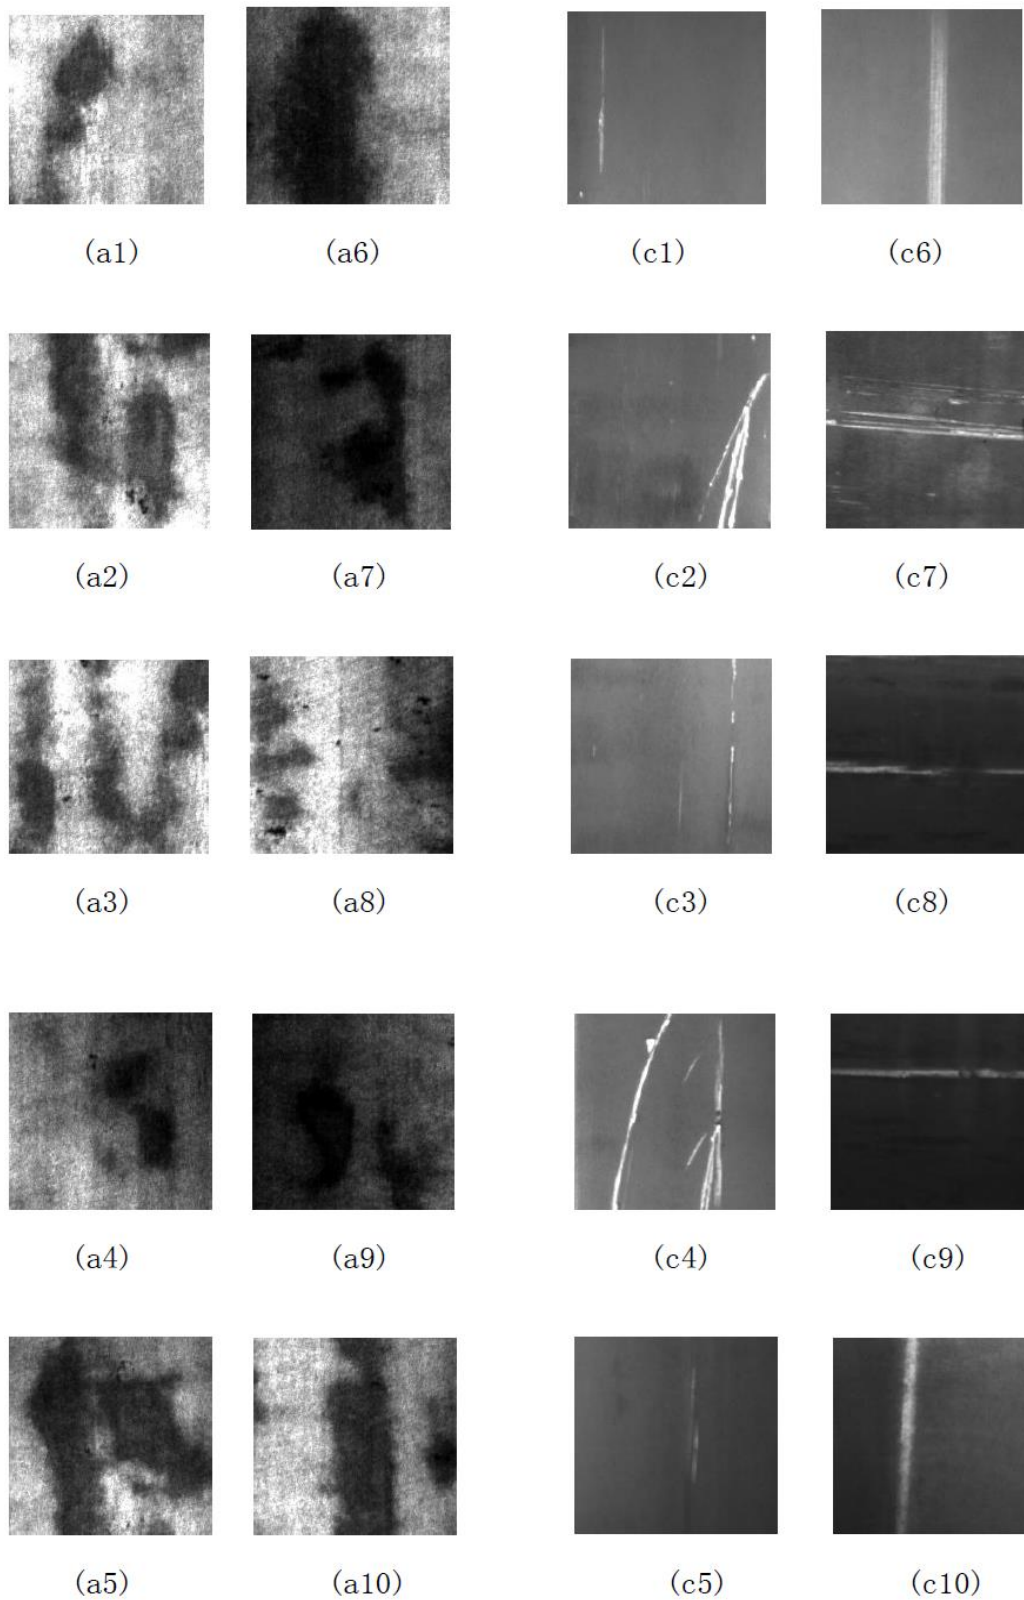
In order to further verify our proposed method, the NEU surface defect database[19] is used, this dataset contain several types of steel defect, heretwo typical surface defects of hot-rolled steel strips are used for our proposed method in this paper, i.e. patches (Pa), scratches (Sc). Some of these samples is shown in Figure 7. There are 300 samples for each type of defect, we use 250 samples for training(80%) and validation(randomly choose 20% of the whole 250 samples as validation data set), and 50 samples for testing, when the training epoch is 7, the training accuracy is over 90%, and the training accuracy arrived 100% when the training epoch is 13; when the training epoch is 44, the validation accuracy is 100%; when the training epoch is 146, the validation loss is 0.001, after 220 epoch of training, the validation loss is zero.

Figure.7. Defects of steel Surface[19]: (a1)-(a10) ten represent defective surface image of patches (Pa); (c1)-(c10) ten represent defective surface image of scratches (Sc);

For testing results, the inspection accuracy of patches is varied from 99.0539% to 99.9998%, the average accuracy for all the testing set of patches defect is about 99.8805%. The inspection accuracy of scratches is varied from 98.2197% to

99.99999%, the average accuracy for all the testing set of scratches is 99.7739%.
