Continuous Casting and Rolling Technology at MKM Mansfelder Kupfer und Messing GmbH – Optimisation of the Surface Quality for Conti-M® Strip

Klaus-Dieter Palm^{1, a}, Hendrik Busch^{1, b *} and Axel Dusdorf^{1, c}

¹MKM Hettstedt GmbH, Lichtlöcherberg 40, D - 06333 Hettstedt, Germany

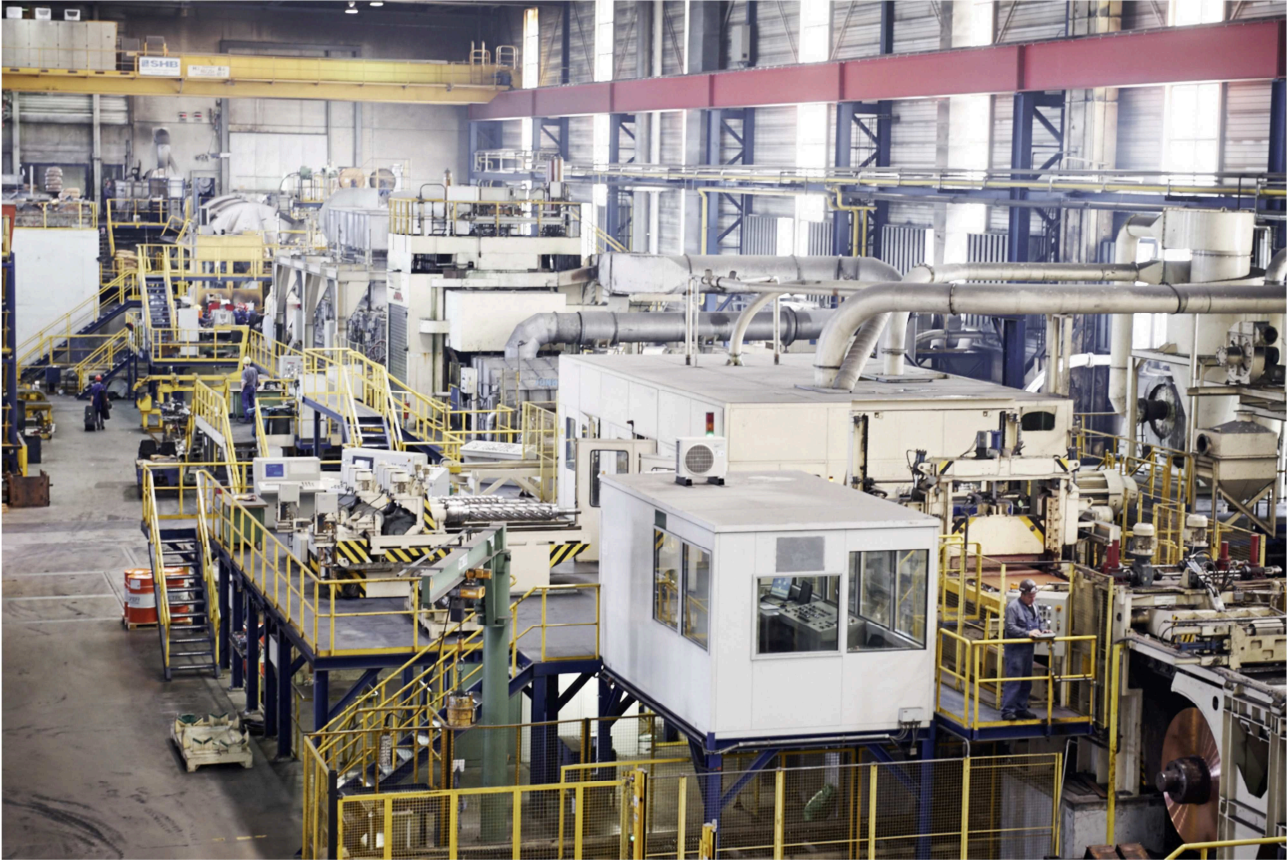
The Conti-M® system (Fig. 1) forms the beginning of a modern technological process chain for manufacturing copper strip in a 360 m long hall. With a maximum casting width of 1290 mm and a melting capacity up to 70 t / h different copper qualities (ETP-Cu, DLP-Cu, DHP-Cu, HCP-Cu, OF-Cu and OFE-Cu) can be continuously produced via a continuous casting and rolling technology in one casting period. A characteristic feature is the technological link between the process steps melting, casting, hot rolling, cooling, surface milling and coiling. These milled copper coils produced by the Conti-M® technology are made not only with shorter lead times of about 2 hours, but also with higher energy efficiency compared to conventional technology.

Fig. 1: Conti-M® Plant (source: MKM)

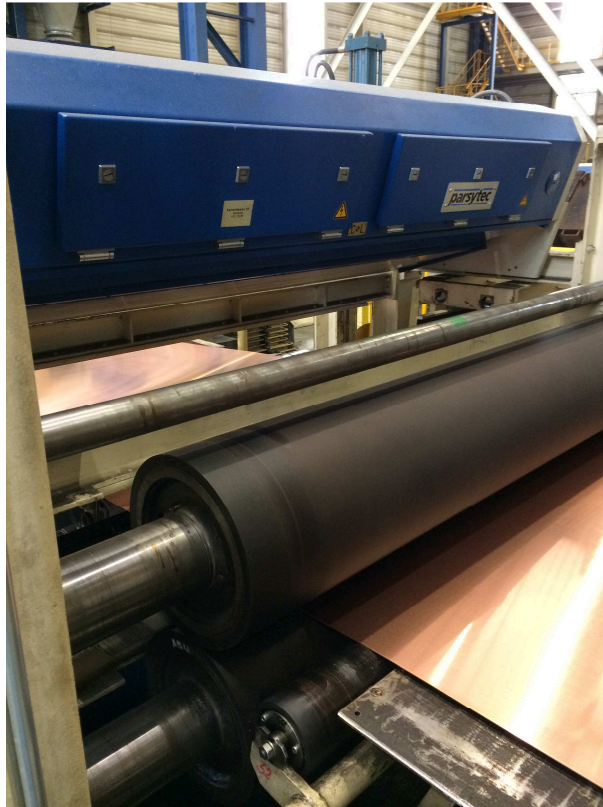
Parsytec is a computerized surface inspection system from ISRA Vision Parsytec (Fig. 3), which allows surface defect detection and defect classification – such as chips, scale residues and surface defects. It consists of one lighting and camera unit, which are aligned on the top and bottom of the strip surface. The lighting unit consists of several LED modules that operate within the infrared range. The camera units detect defects based on gray value differences from the images. The detected images then pass through a classifier which then assigns the defect to a particular category. This classification process needs to be periodically renewed and optimised to ensure the best possible outcome.

Fig. 3: ISRA Parsytec-system at a slitting and cut-to-length line for copper strip at thickness of 2 mm (source: MKM)

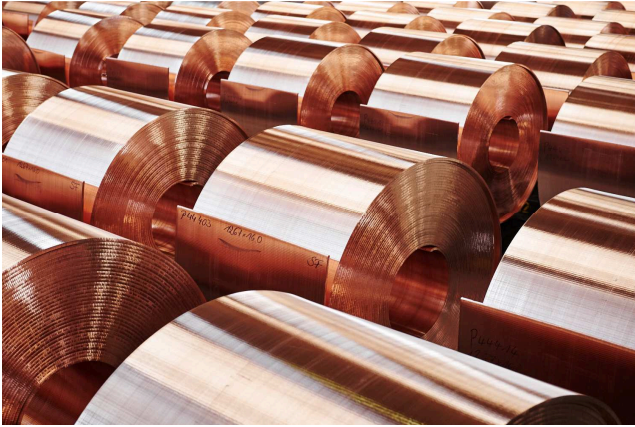
The surface inspection system from ISRA Parsytec is a complete, fully comprehensive quality testing system for the surface of strip (Fig. 6, Fig. 7), which is the evidence of process safety in the continuous casting process. This ensures that the milled surface is free from failures in the subsequent process chain when passing through.

Fig. 6: Cast-rolled copper strips from Conti-M® (source: MKM)
